# UNDERWATER BRIDGE INSPECTION REPORT

STRUCTURE NO. 73514

SAINT GERMAIN STREET (MSAS NO. 128)

MISSISSIPPI RIVER

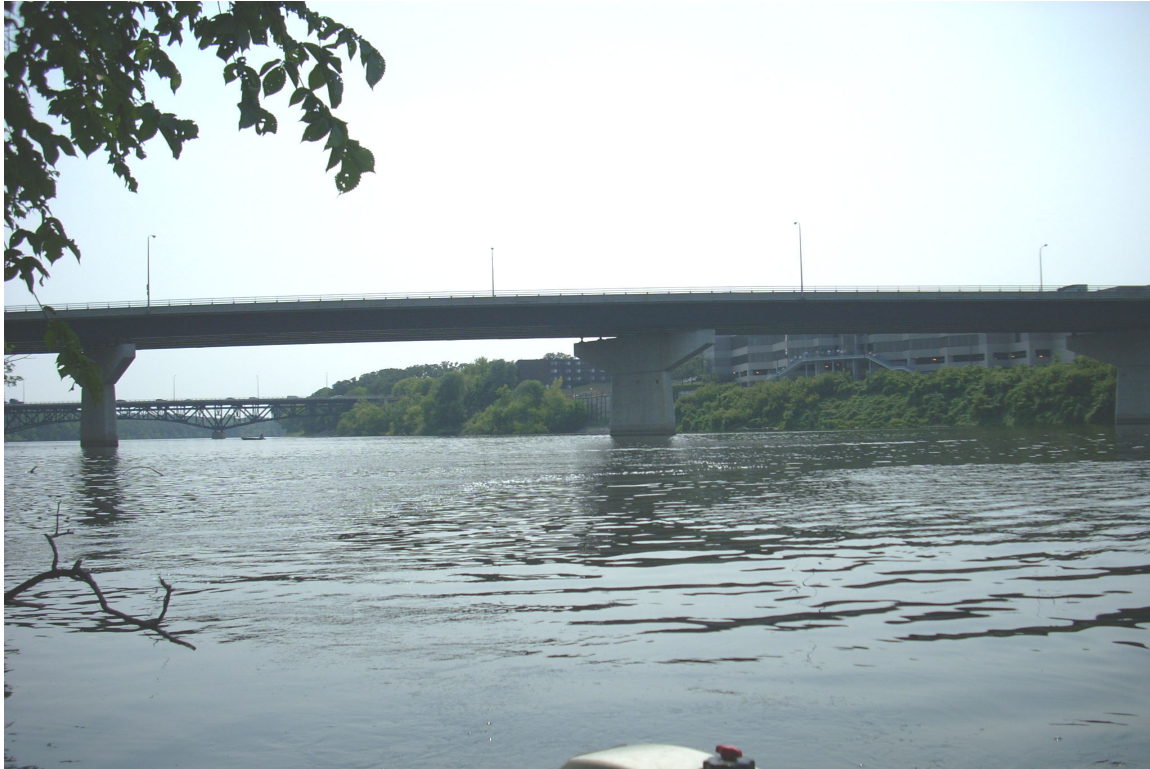
Photograph 1. Overall View of Piers 1 and 2, Looking East.

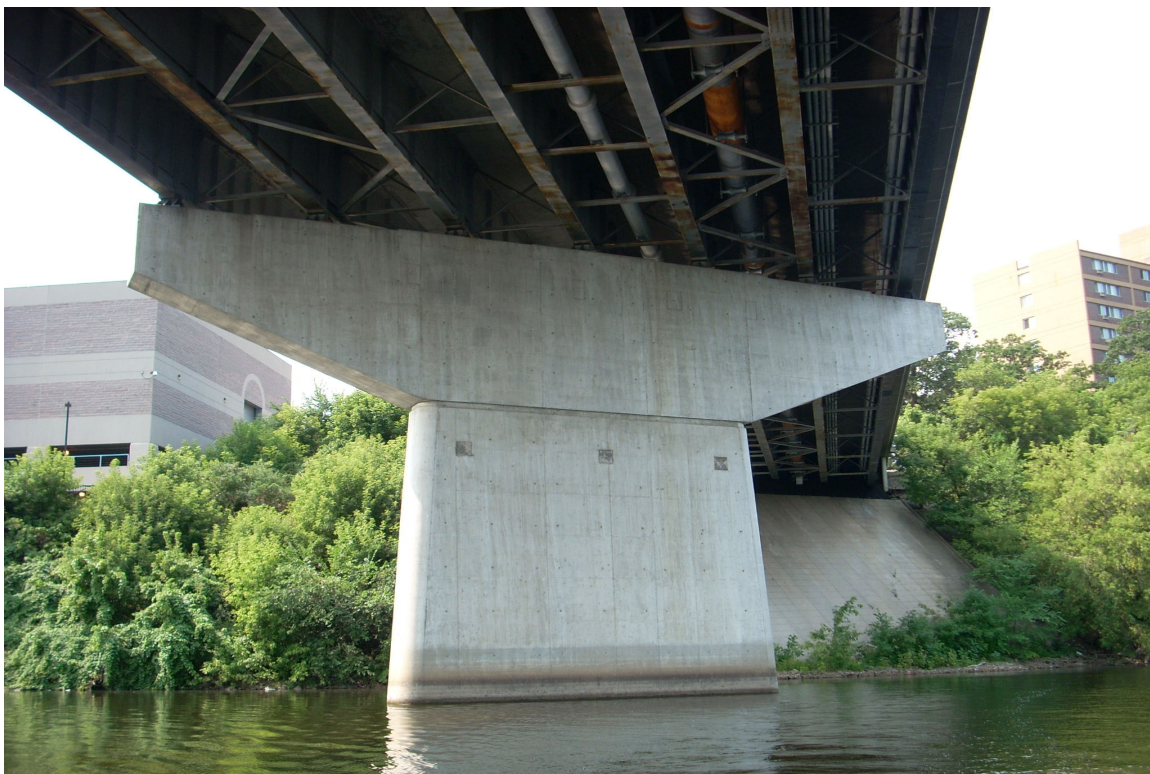
- (A) The footing at Pier 1 was exposed 5 feet across the upstream side of the pier, immediately around the upstream nose, and for approximately 10 feet along the south side of the pier with a maximum vertical exposure of 1 foot at the upstream end.

Photograph 2. View of Pier 1, Looking South.

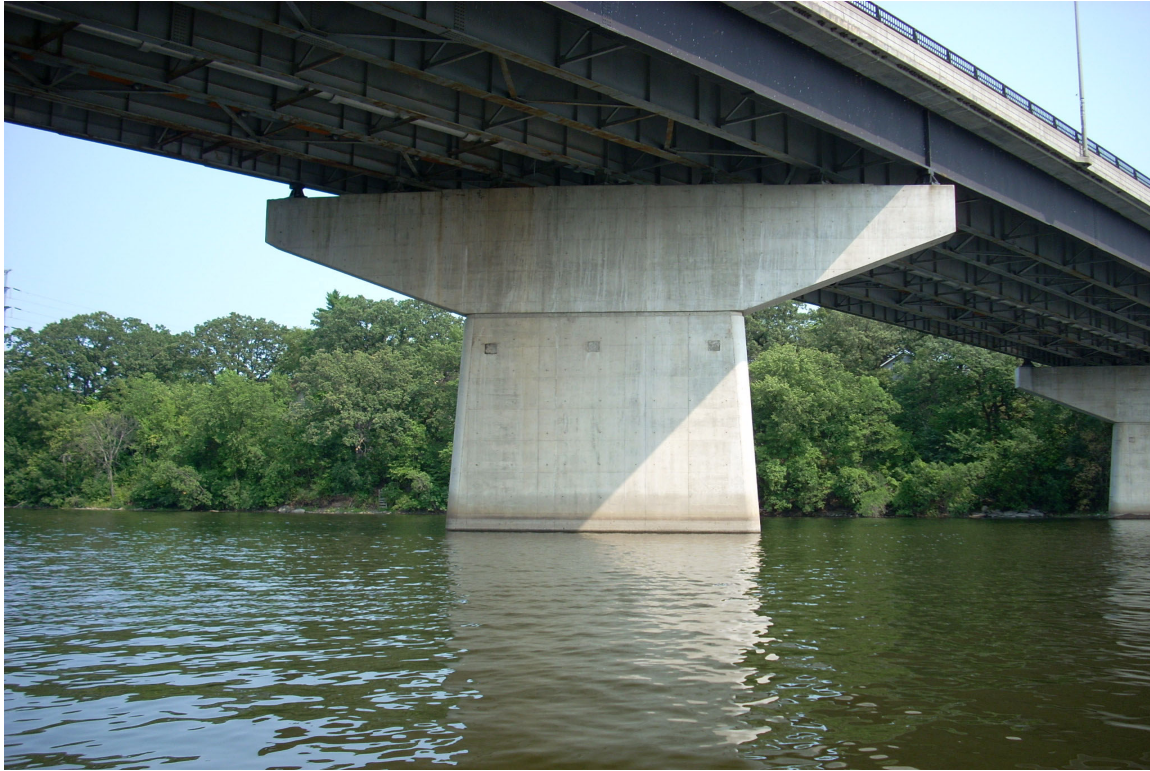
- (B) Footing exposure was detected across the entire upstream nose and extending approximately 8 feet down the south face and 5 feet down the north face of Pier 2 with a maximum vertical face exposure of 8 inches at the upstream end.

Photograph 3. View of Pier 2, Looking Northwest.

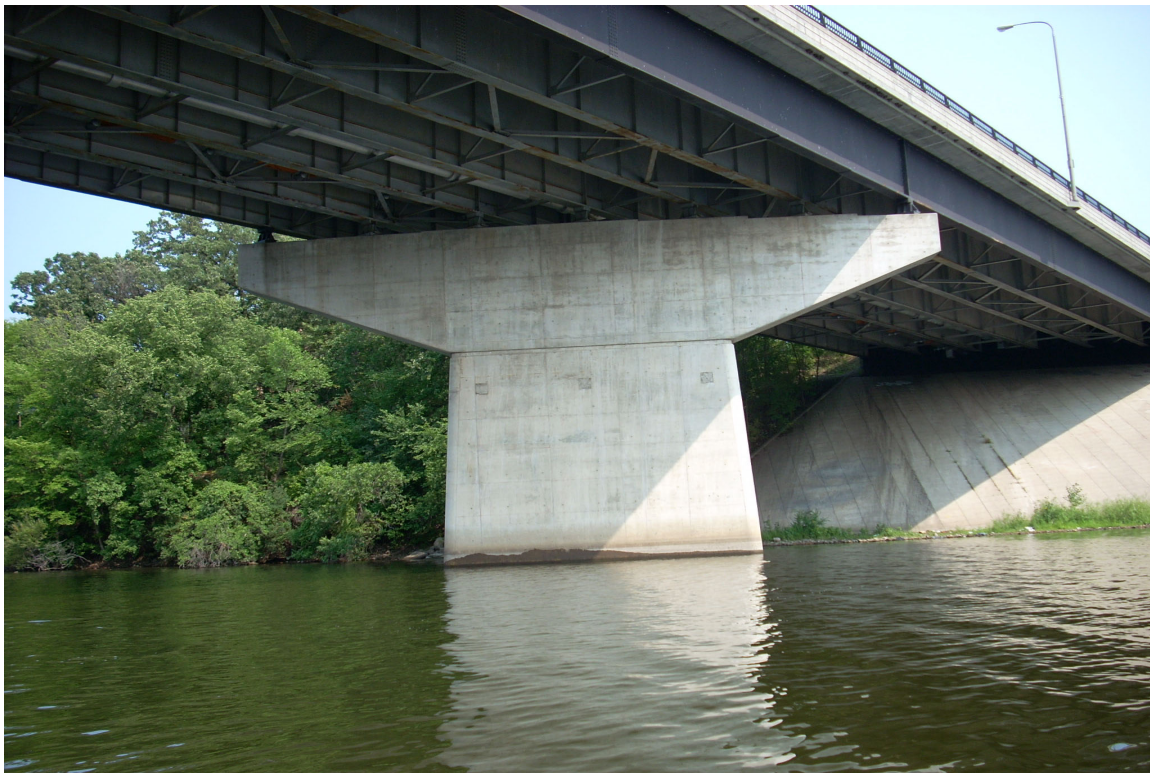
Photograph 4. View of Pier 3, Looking Northwest.

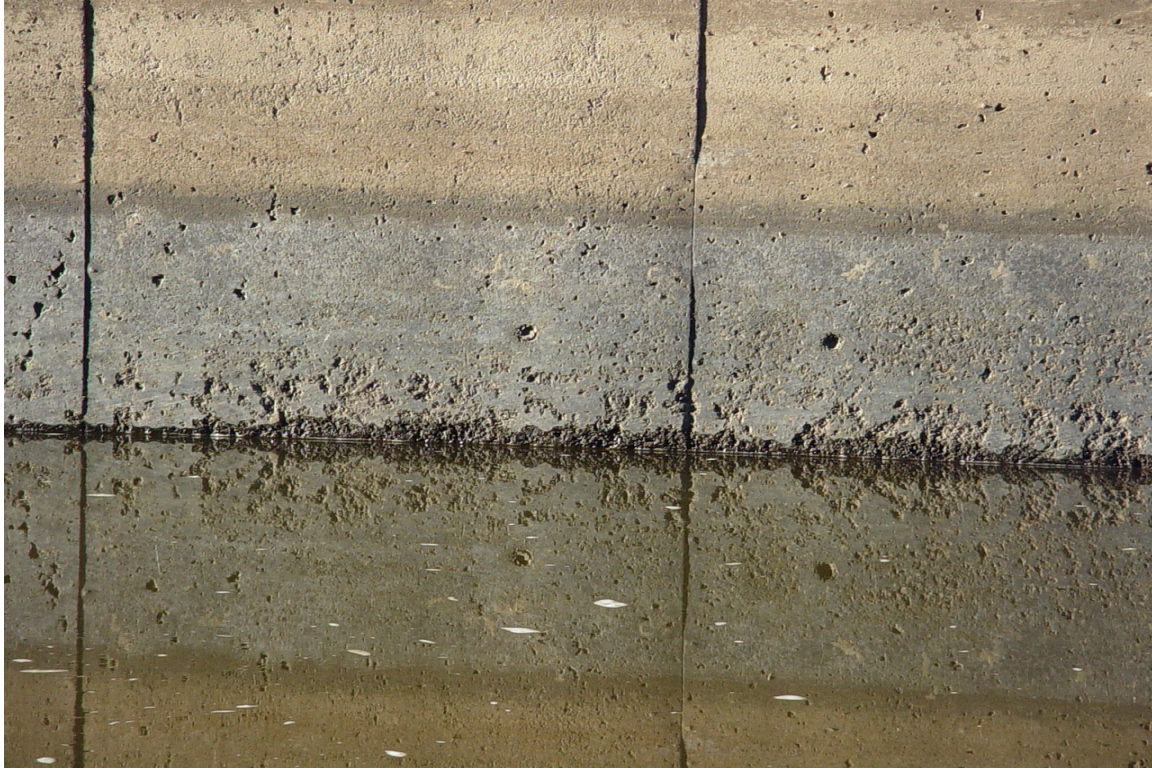
- (D) Light scaling with a maximum penetration of 1/8 inch and minor areas of impact damage with penetrations of up to 1/2 inch was observed on all piers from 3 feet above to 1 foot below the waterline.

Photograph 5. Close up View of Typical Light Scaling around Mid Section of Pier 3 at the Waterline, Looking South.

- (A) Reinspect the submerged substructure units at the normal maximum recommended (NBIS) interval of five (5) years.

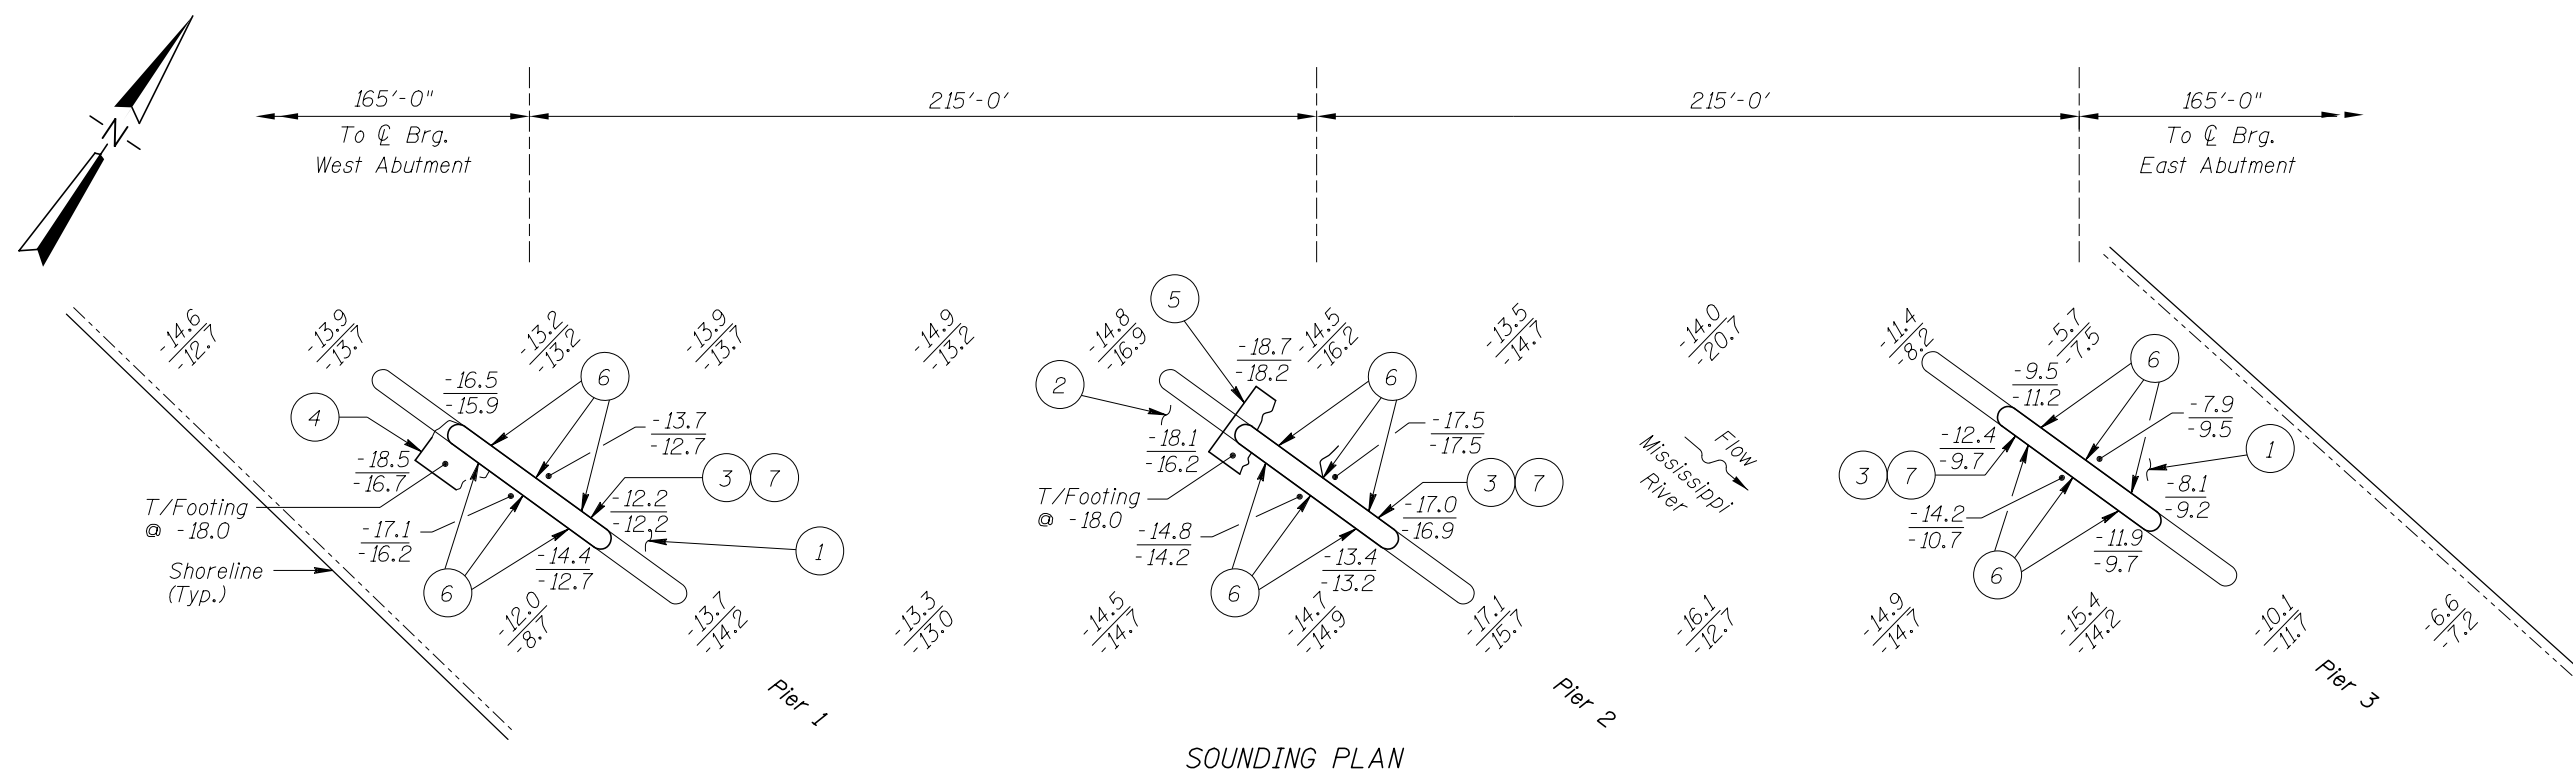
**INSPECTION AND SOUNDING PLAN**

- 1 The channel bottom material at Pier 1 and 3 consisted of 12- to 18-inch-diameter riprap with sand infilling and no probe rod penetration.
- 2 The channel bottom material at Pier 2 consisted of 1-foot-diameter riprap with sand and gravel infilling and up to 4 inches of probe rod penetration.

- 3 Light scaling with a maximum penetration of 1/8 inch and areas of impact damage with penetration up to 1/2 inch were observed on all piers from 3 feet above to 1 foot below the waterline.

- 4 Footing exposure was detected, extending 5 feet across the upstream face, immediately around the nose, and for approximately 10 feet along the south side of Pier 1 face with a maximum vertical face exposure of 1 foot at the upstream end.

- 5 Footing exposure was detected across entire upstream nose and extending approximately 8 feet down the south face and 5 feet down the north face of Pier 2 with a maximum vertical exposure of 8 inches at the upstream end.

- 6 A line of 3 steel I-beams was observed extending through all of the piers and cut flush with the pier shaft faces at 5 feet and 11 feet below the waterline. The concrete surrounding the I-beam was smooth with no deficiencies.

- 7 Above and below scaling, the concrete surfaces of pier shafts and footings (where exposed) were typically smooth and sound with random minor areas of poor consolidation up to 1/4 inch penetration.
